Construction General Permit Compliance Evaluation Inspection Report

**Burma Road
Gotham Bay Road to Junction SH 97
Coeur d' Alene, Idaho**

**NPDES Permit Tracking Numbers:
IDR12C962, IDR12C968 and IDR12C974**

**Inspection date: March 25, 2014
Report completion date: May 21, 2014**

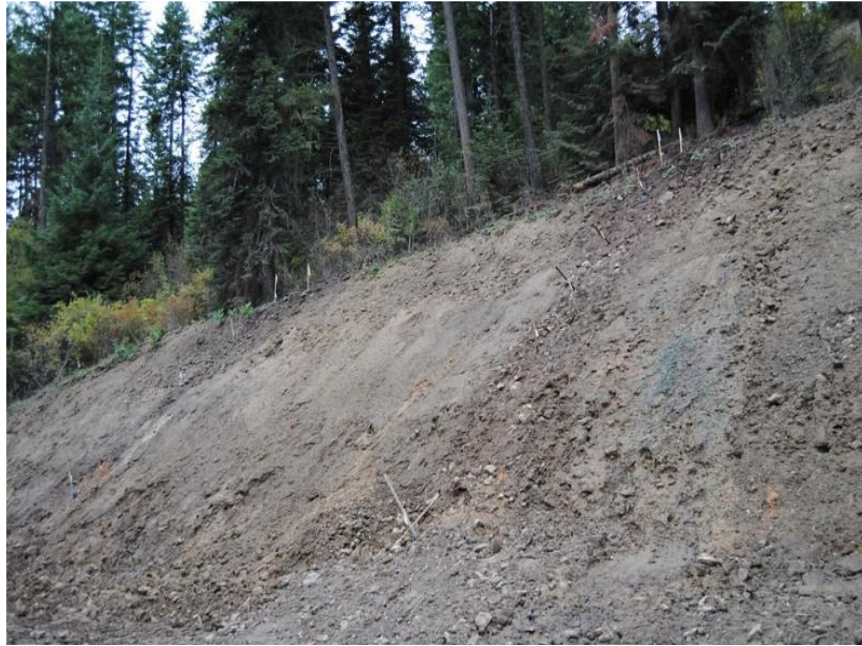
Photo No. 5 - Photo and description from report by Karissa Hardy, Rain Event 9/28/2013 – 9/30/2013
“Failed sloped with tackifier and mulch”

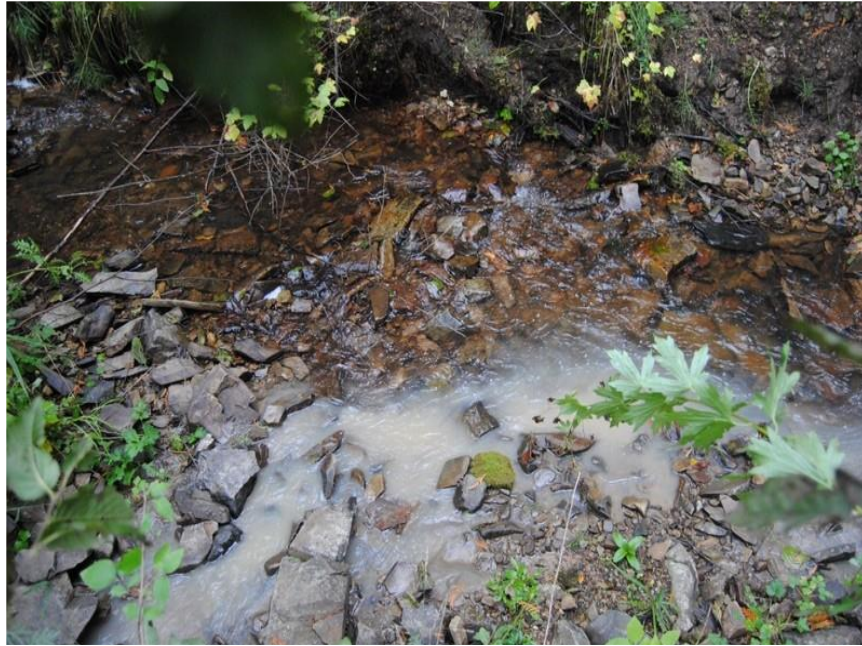
Photo No. 7 - Photo and description from report by Karissa Hardy, Rain Event 9/28/2013 – 9/30/2013
“Project discharge at Turner Creek”; according to Karissa Hardy (phone conversation on 05/08/2014), this is not actually direct runoff from the project but the confluence of Turner Creek and an unnamed tributary that does convey runoff from the project.

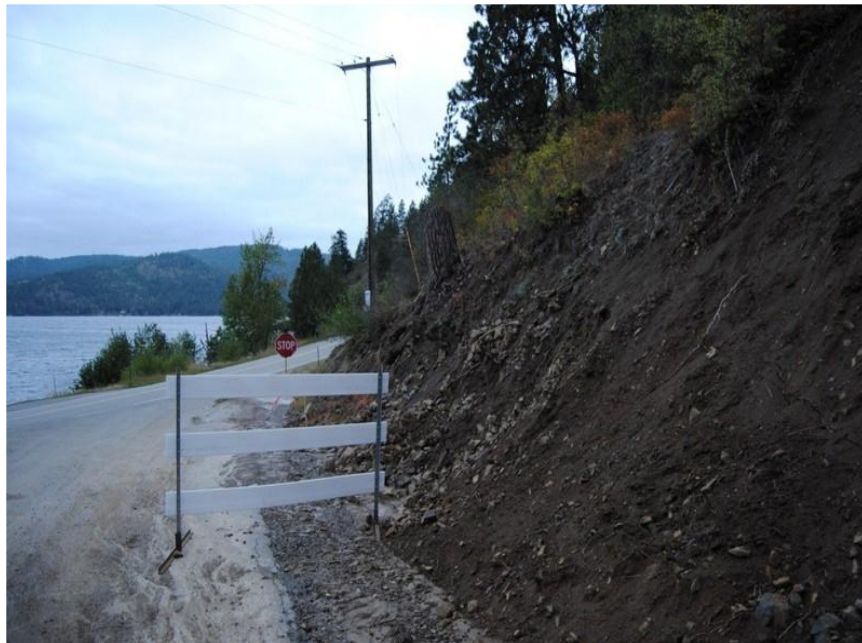
Photo No. 10 - Photo and description from report by Karissa Hardy, Rain Event 9/28/2013 – 9/30/2013
“Failed slope near Lake Coeur d’ Alene” at junction of Burma Road and SH 97 (PS)

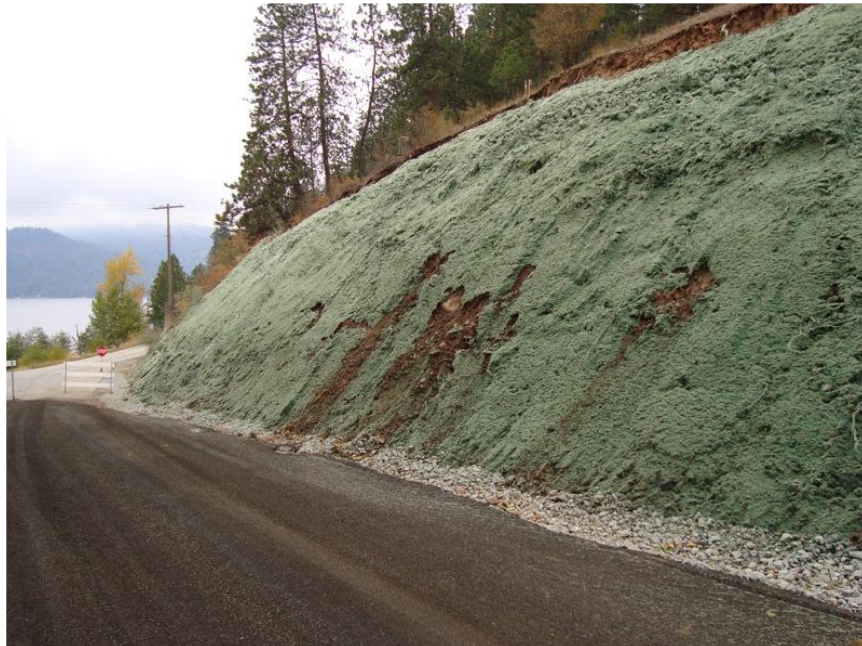
Photo No. 11, Photo by June Bergquist; 10/10/2013
Slope failure, post BFM application, near junction with SH 97

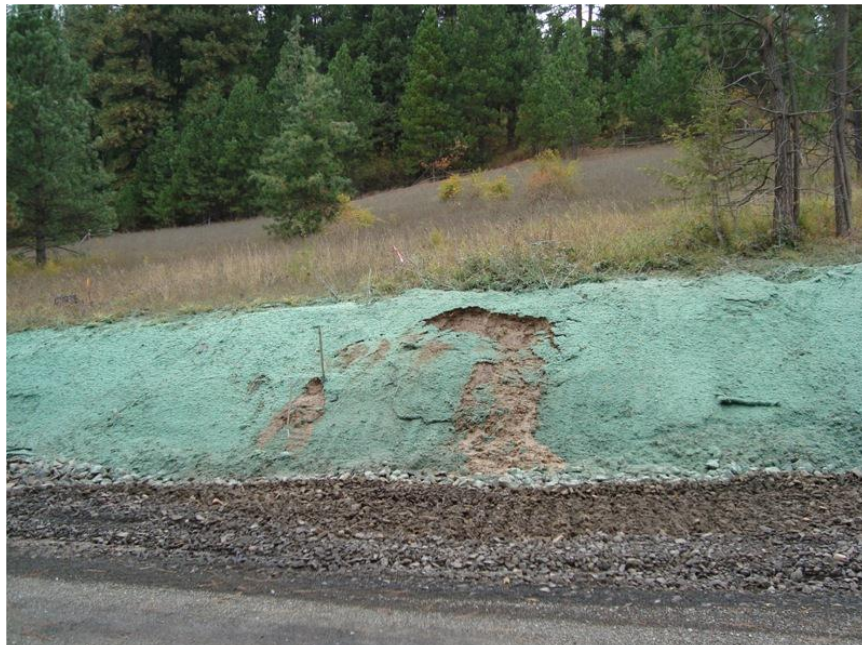
Photo No. 12, Photo by June Bergquist; 10/10/2013
Additional slope failure, post BFM application, east of junction with SH 97

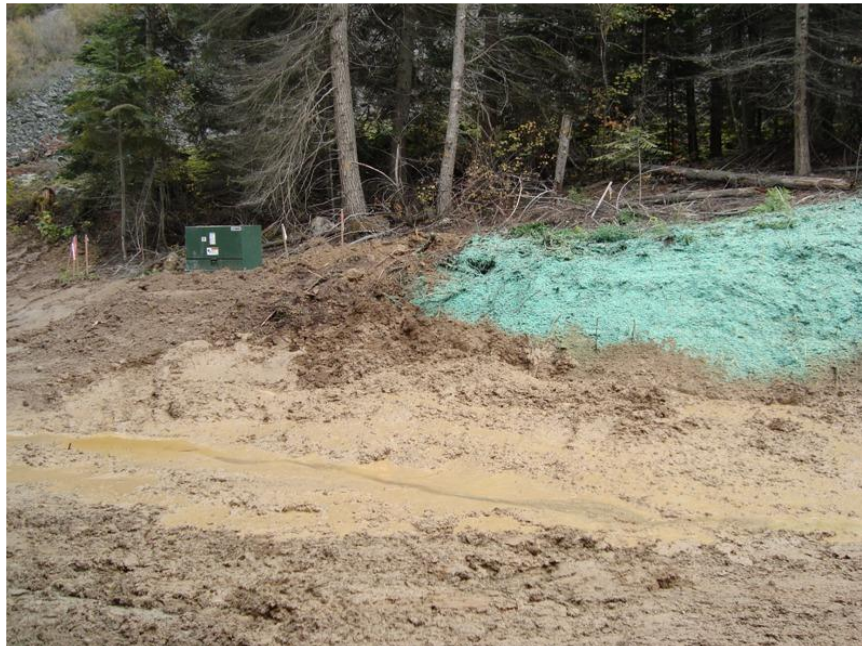
Photo No. 13, Photo by June Bergquist; 10/10/2013
Saturated soil and slope failure east of E. Litten Lane

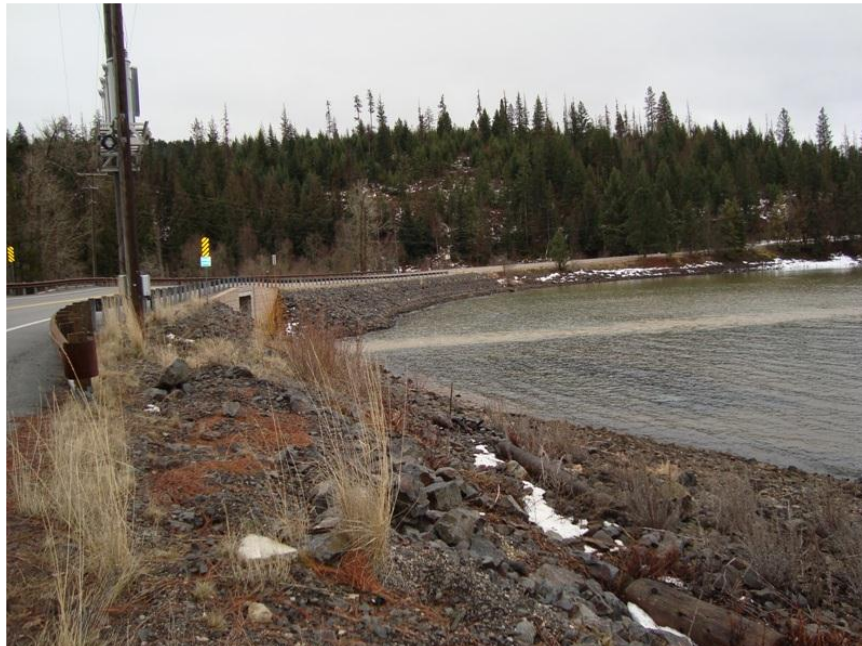
Photo No. 15, Photo by June Bergquist; 03/07/2014
Plume from Turner Creek into Turner Bay/Lake Coeur d' Alene; facing SE

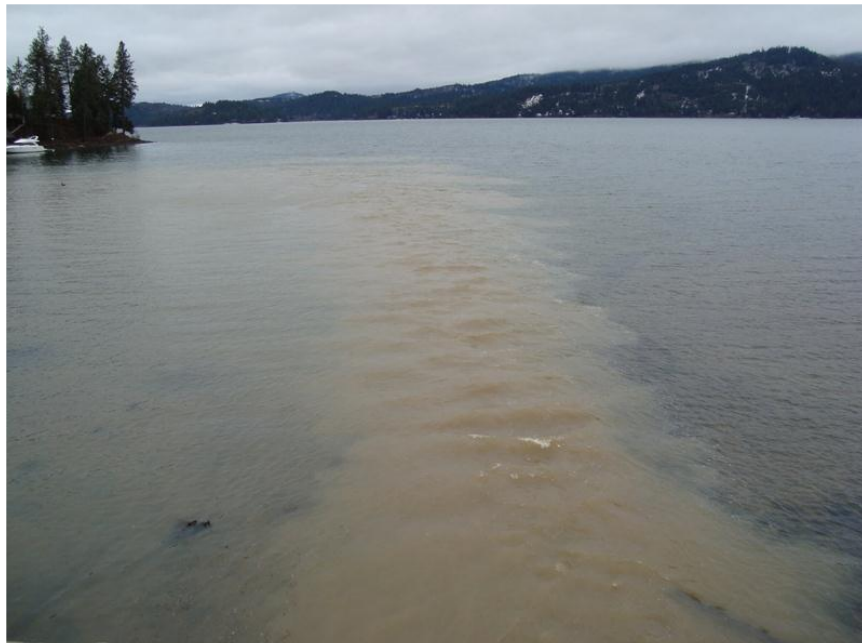
Photo No. 16, Photo by June Bergquist; 03/07/2014
Plume from Turner Creek into Turner Bay/Lake Coeur d' Alene; facing SW

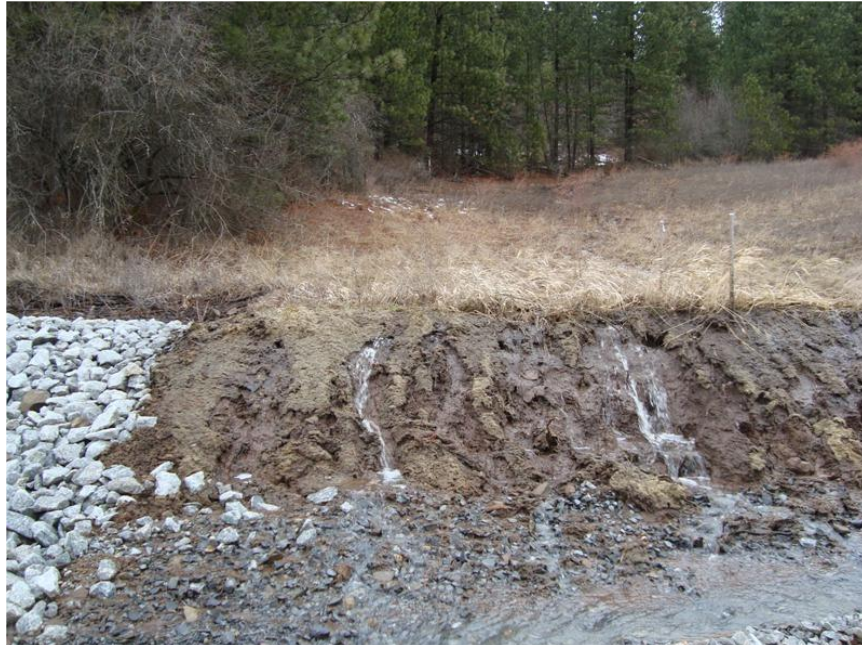
Photo No. 17, Photo by June Bergquist; 03/07/2014
Seeps discharging from bank; all BFM appears to have sloughed off the face of the slope.

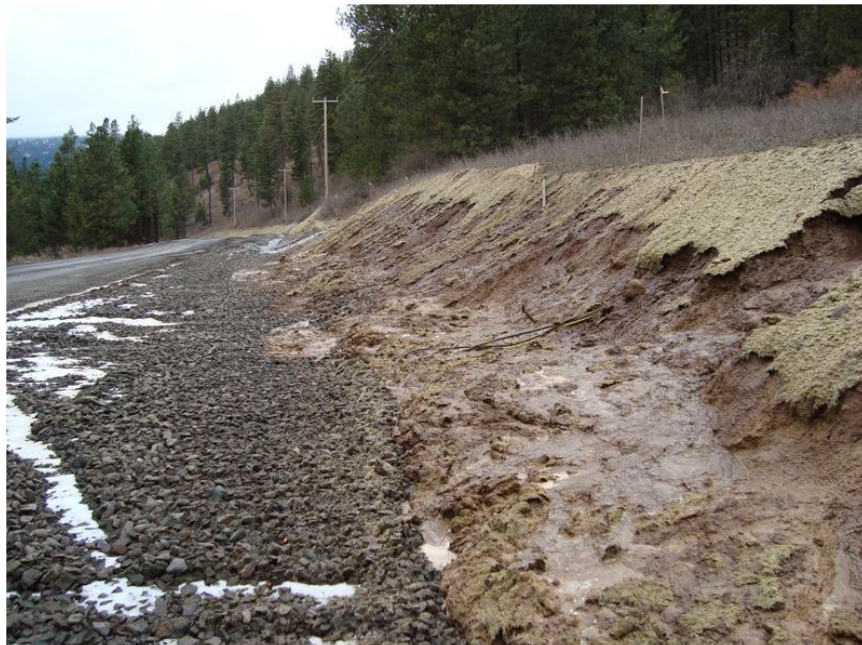
Photo No. 18, Photo by June Bergquist; 03/07/2014
More evidence of slope failure – minimal BFM remaining at the top of the slope.

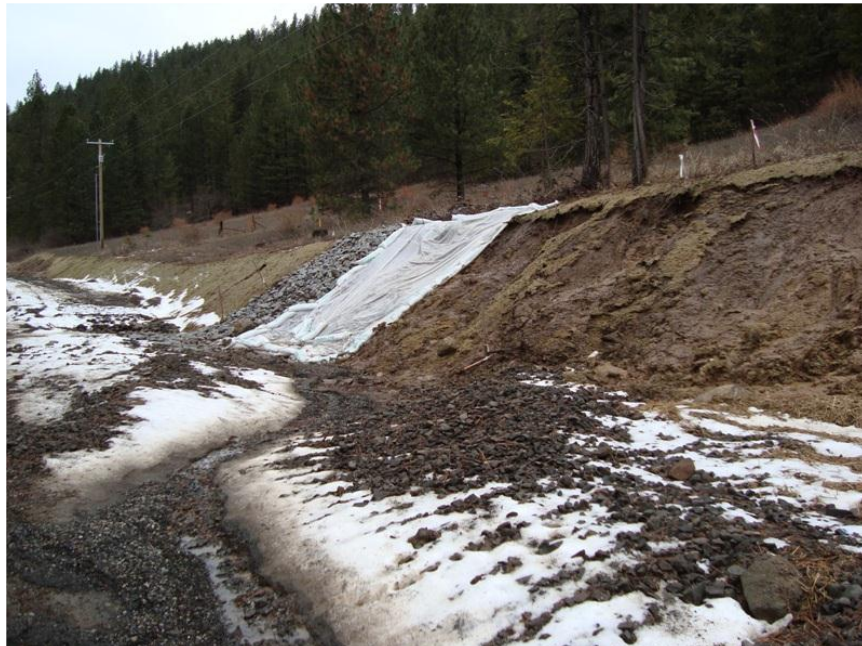
Photo No. 19, Photo by June Bergquist; 03/07/2014
Visqueen on slope

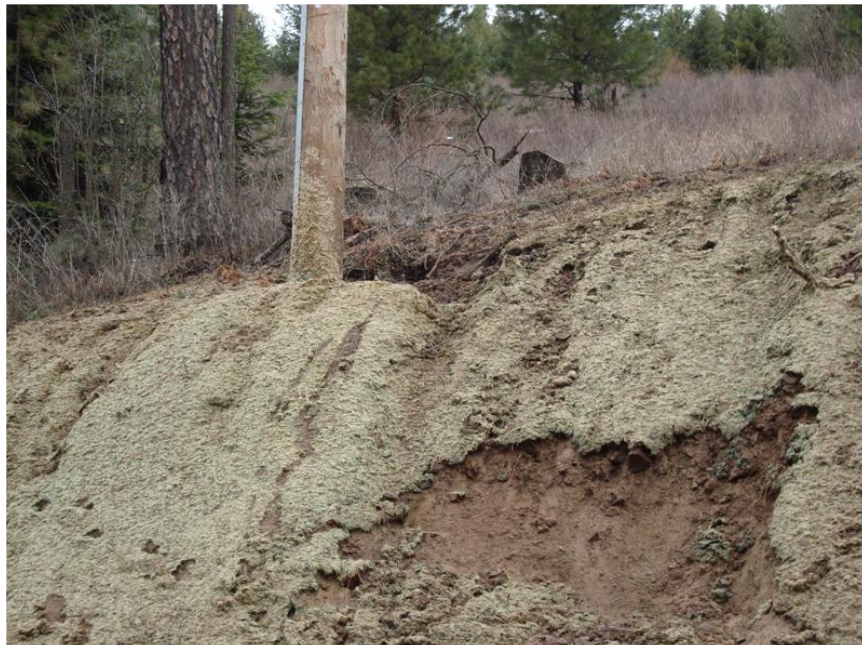
Photo No. 20, Photo by June Bergquist; 03/07/2014
BMF and slope failure; this utility pole eventually required restabilization.

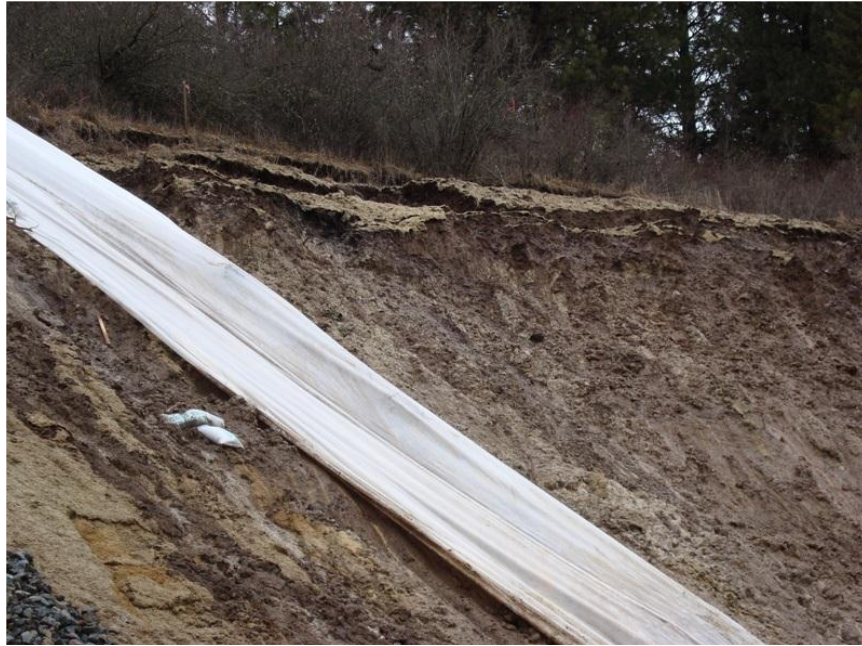
One of the most problematic areas observed during the site tour (conducted primarily on foot starting from the west end of the project at the intersection with SH 97) involved the steep cut slope along the entrance to E Litten Lane. According to the stormwater inspection reports, this slope has exhibited extensive slope failure since January, 2014 at the latest. Project engineers claim that the slope is currently too unstable to safely implement a long-term solution (there may also be an easement issues since so much of the slope has sloughed off ; any long-term fix will likely require the removal of soil to reduce the angle of the slope which will, in turn, require the acquisition of property rights beyond the existing slope). As a temporary measure, "eco-blocks" (large concrete barriers made from left-over or unused concrete) have been placed along the toe of the slope to keep soil from inundating E. Litten Lane. The slope face was hydroseeded the very day of this inspection; the E. Litten Lane slope was bare when I passed it on the way to the construction site office in the morning but it was coated with the green hyroseed material by mid-afternoon. Portions of the slope had already begun to show signs of slope failure by the time the tour began (see Photos 41 and 44). A major slope failure at E. Litten Lane could result in the discharge of significant amounts of sediment to Turner Creek.

Photo No. 21, Photo by June Bergquist; 03/07/2014
Slope failure at E. Litten Lane – note beginning of new separation at crest.

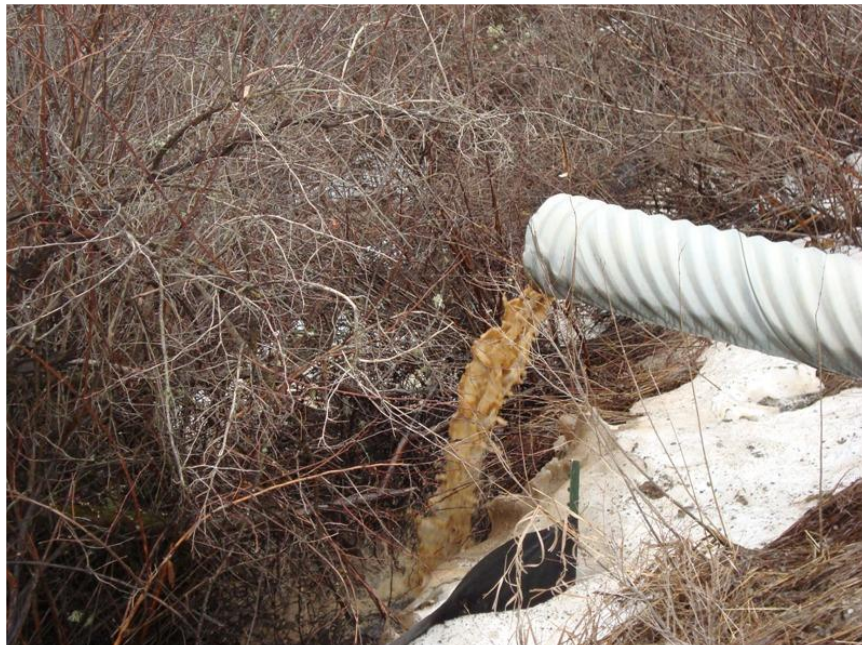
Photo No. 22, Photo by June Bergquist; 03/07/2014
Turbid stormwater discharge from roadside ditch to vegetative buffer before Turner Creek.

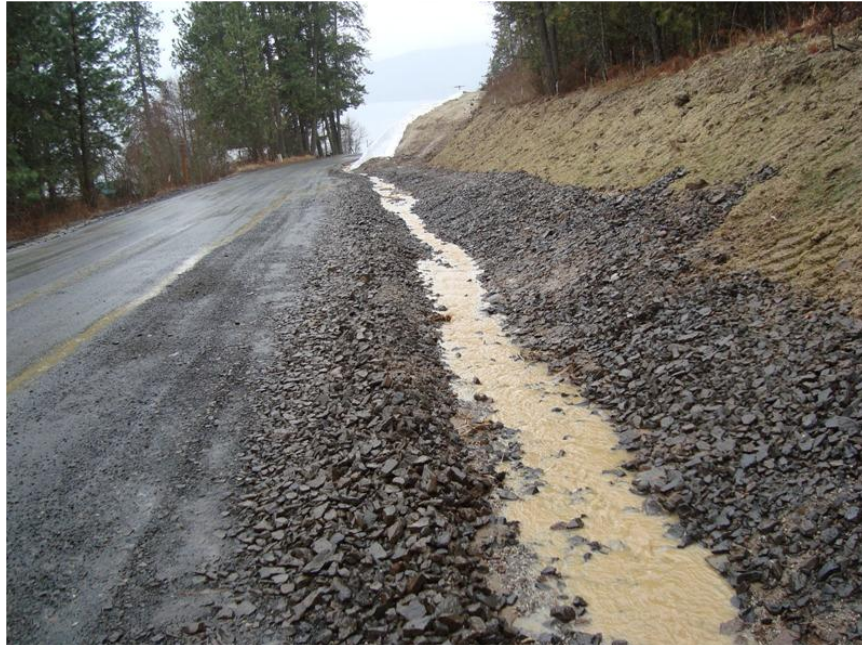
Photo No. 23, Photo by June Bergquist; 03/14/2014

Turbid runoff in ditch on north side of the road; this runoff would flow into a ditch on the east side of SH 97. Operators claimed all water seeped into ditch. (statement to Stoll on 03/25/2014).

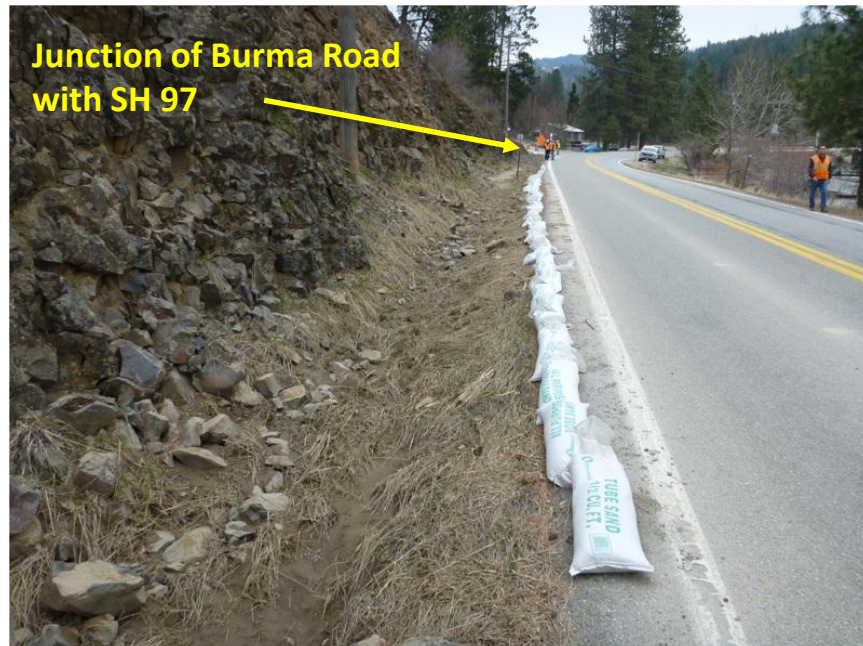
Photo No . 25 (P1000410)

Facing south on Highway 97; ditch conveys some stormwater from the Burma Road project; at high flow, stormwater runoff has flowed across the highway with potential discharge to Lake Coeur d' Alene.

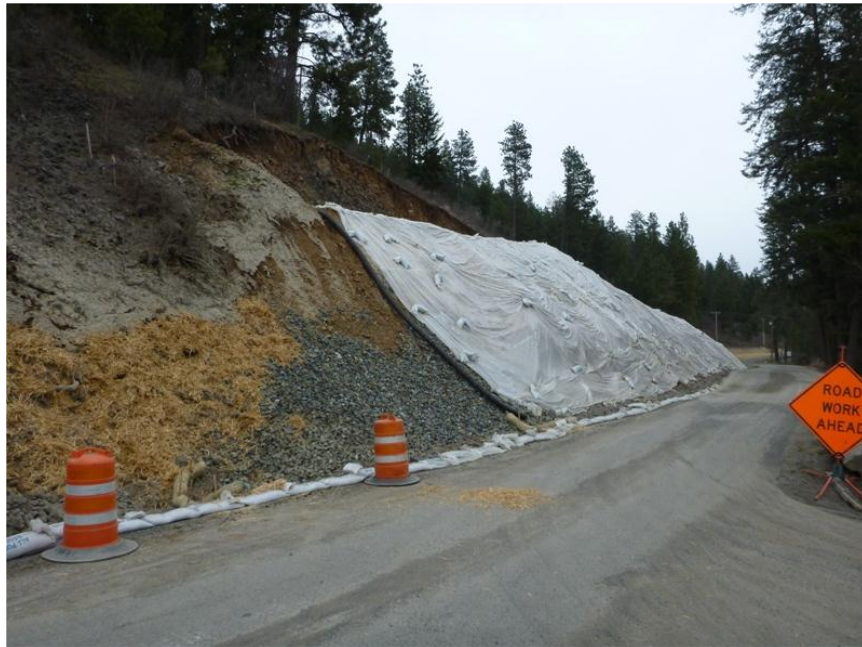
Photo No. 27 (P1000413)
Facing NE – the first steep slope at the beginning of the project;
note remnants of the failed bonded fiber matrix (BFM).

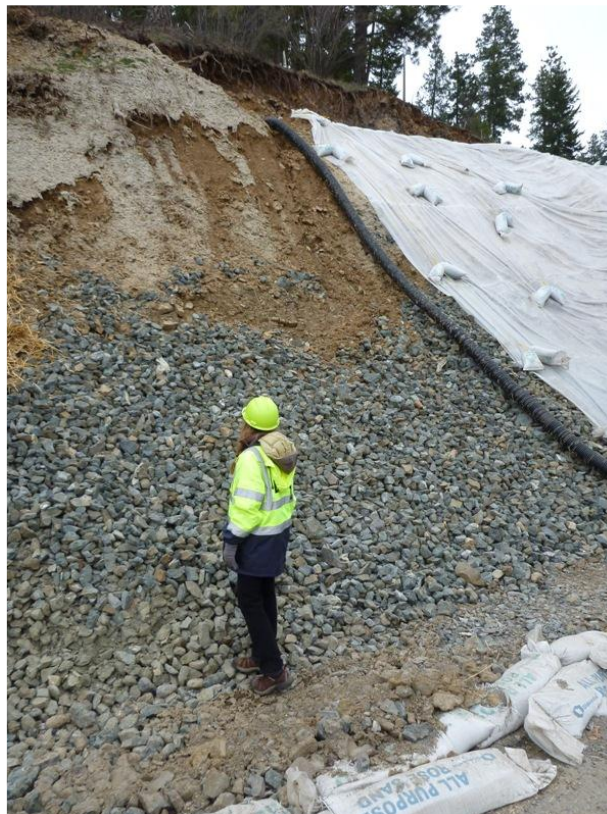
Photo No. 28 (P1000414)
The black plastic pipe conveys water from seeps in the upper cut to rock-lined ditch; rock armors
part of slope where BFM has sloughed off; visqueen protects slope from rain/splash impact.

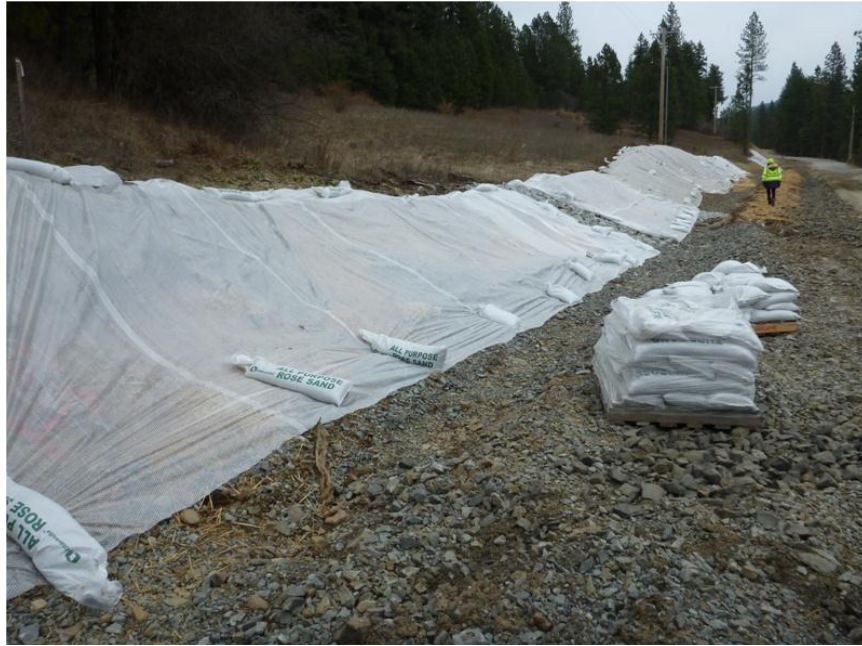
Photo No. 31 (P1000420)

Facing east – the BFM has failed throughout this section; the visqueen (plastic) is intended to protect the bare slopes from direct rain impact to prevent splash erosion.

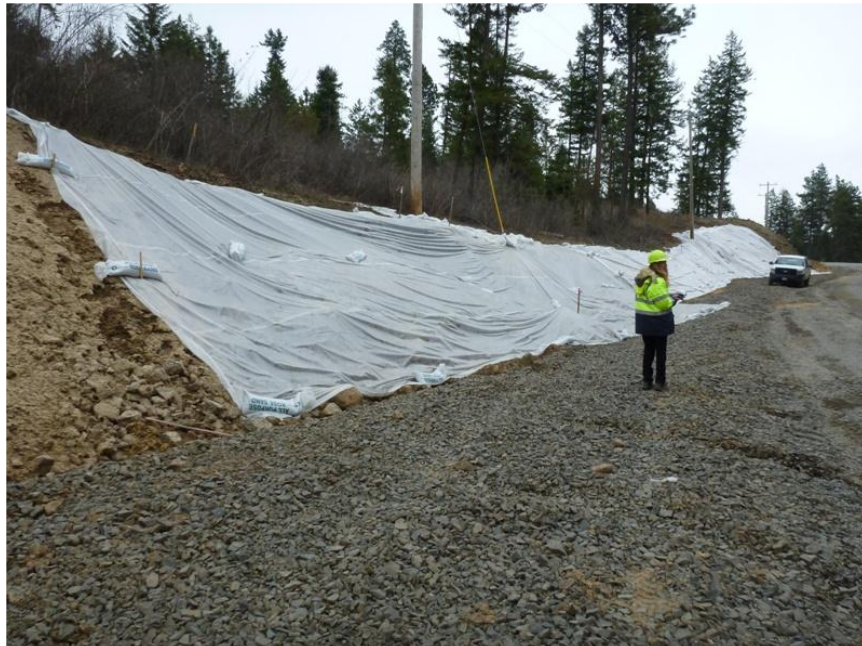
Photo No. 33 (P1000422)

Facing northeast – one of the many areas where the BFM has washed away from the slope face.

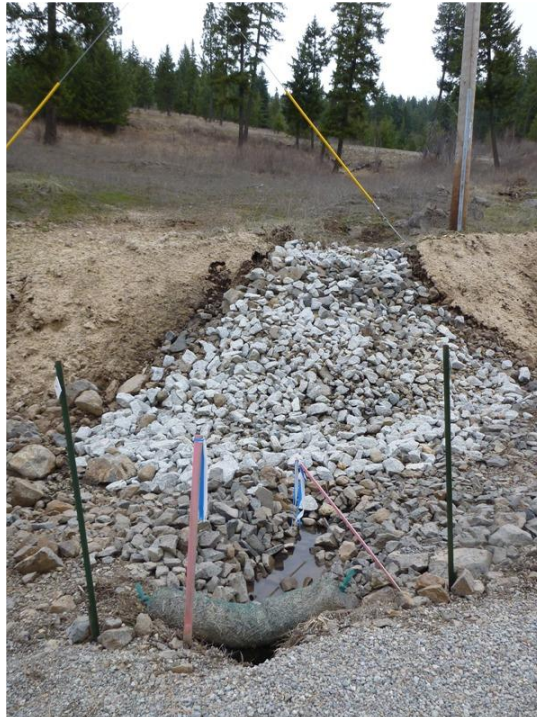
Photo No. 35 (P000424)

Facing north – slope failure (in area where rock armor has been applied) threatened the integrity of this utility pole; the utility company has stabilized the pole.

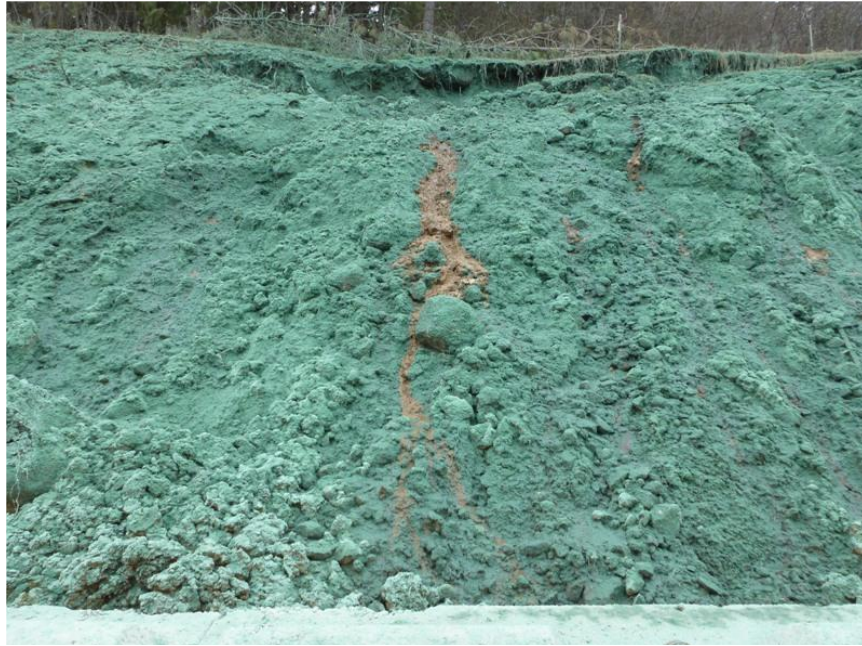
Photo No. 41 (P1000433)

Facing northwest – the slope failure at E. Litten Lane appears to be an almost continuous and ongoing occurrence. The green hydroseed was applied just a few hours before the site tour.

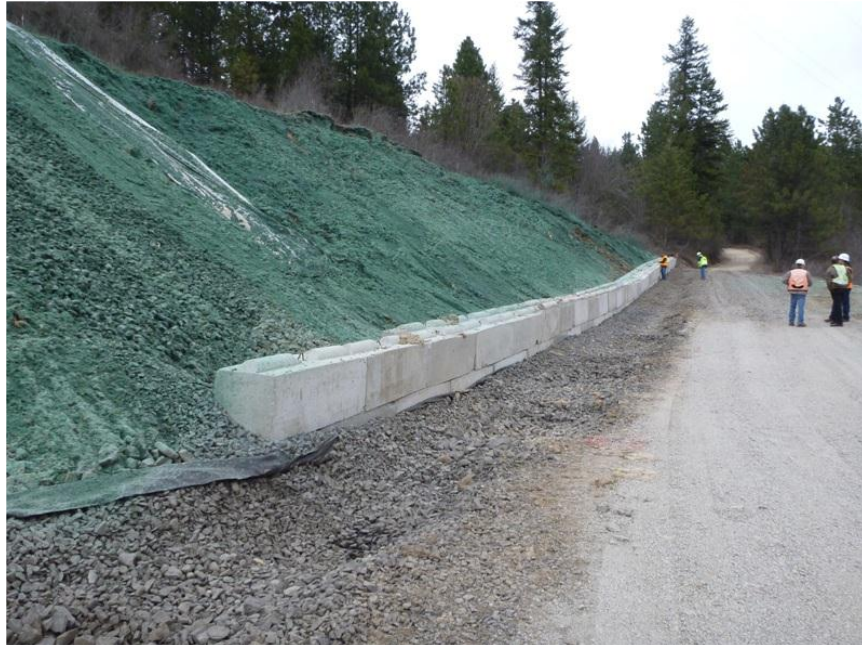
Photo No. 43 (P1000437)

Facing northeast – this is the unstable slope along E. Litten Lane. According to the operators, fissures forming along the top of the slope (parallel with the crest) suggest that additional failures are imminent.

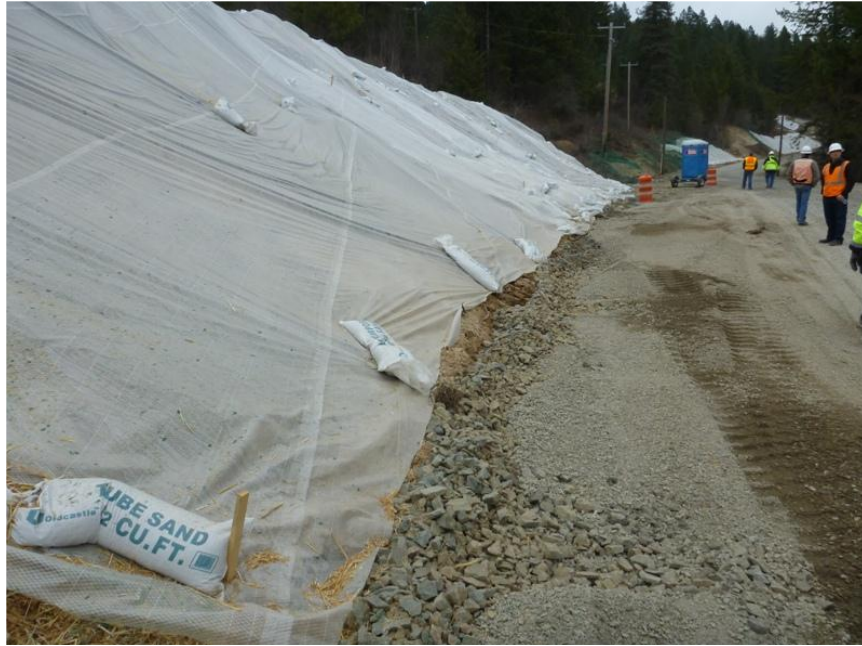
Photo No. 45 (P1000442)

Facing east – the eroded slopes along Burma Road east of the junction with E. Litten Lane.

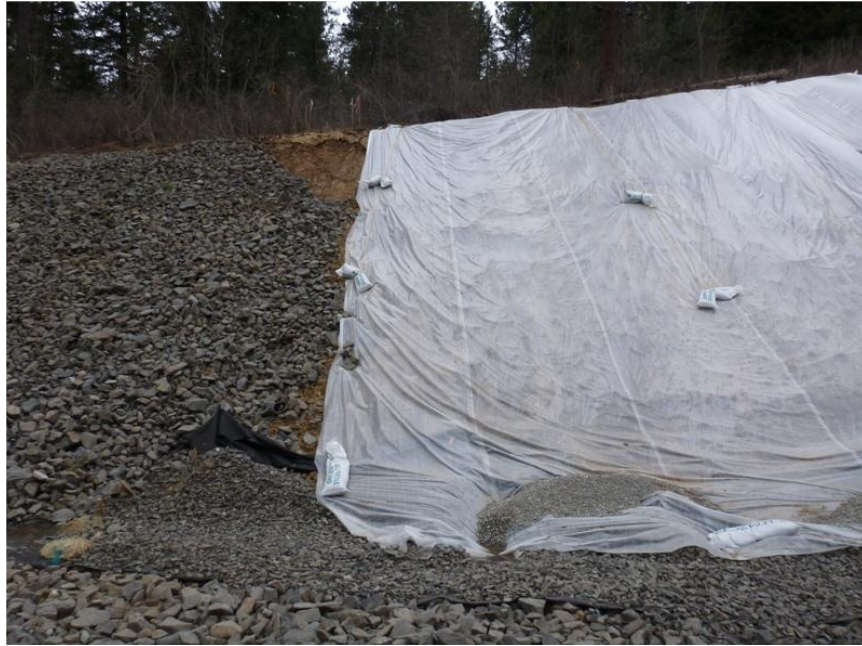
Photo No. 47 (P1000445)
Facing north – rock armoring and visqueen used to control erosion
on slopes throughout the site.

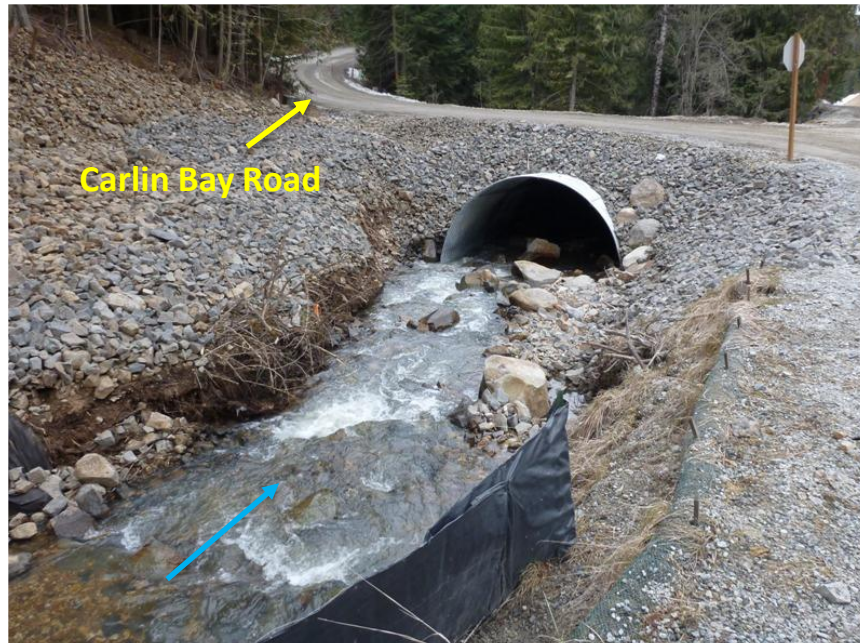
Photo No. 48 (P1000449)
Facing west southwest – Turner Creek flows through new culvert installed below Carlin Bay Road as
part of the Burma Road Project. The freshly cut banks along the creek were
eroded during the winter rainfall events.

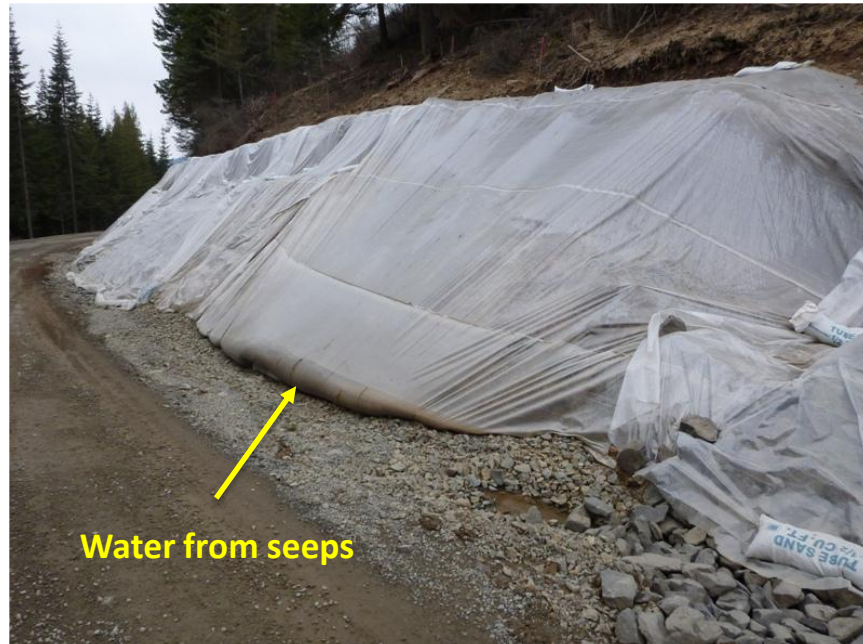
Photo No. 50(P1000451)

Facing southwest – water flowing from the seeps in the slope is retained in the visqueen near the upper portion of the project.
